Watermeade Valley Home Inspection

Property Inspection Report

21907 Oak St., Spanaway, WA 98381
Inspection prepared for: Barney Rubble
Real Estate Agent: Maybelline Agent - Acme Real Estate Co.

Date of Inspection: 12/1/2013 Time: 11:30 AM
Age of Home: 1996 Size: 1921 square feet
Weather: rainy and cool
Washington State Department of Agriculture ICN 7654BH01x

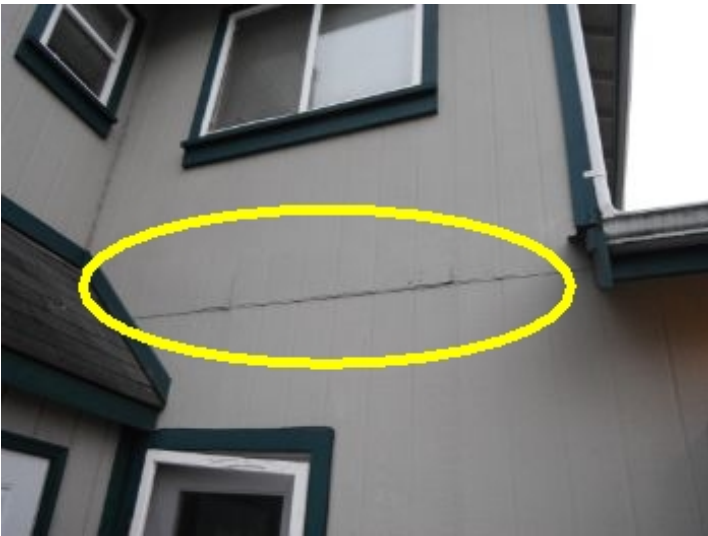
• This home is clad with composition wood fiber siding. Many brands of this type of siding are known to deteriorate and fail prematurely because of moisture. Failure is typically seen as swelling, cracking, and delamination, especially at the bottom edges. Some of this home's siding is showing moderate signs of deterioration. We recommend that a qualified contractor evaluate and replace siding as necessary.

siding beginning to fail

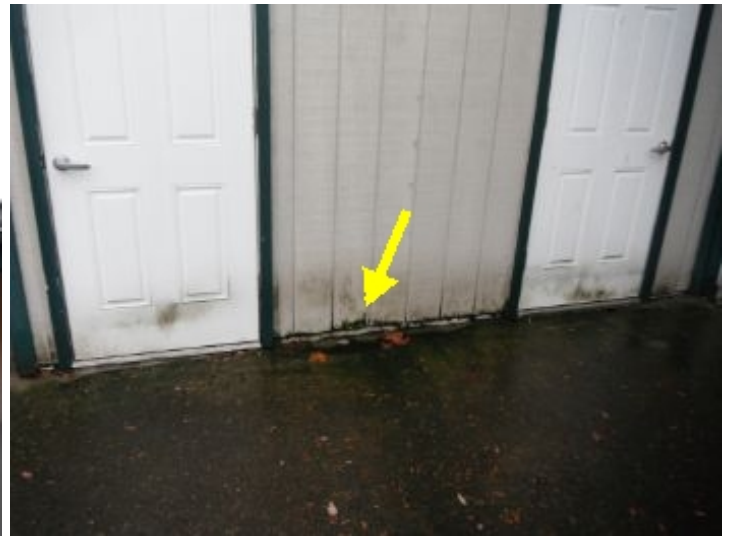
deteriorated siding

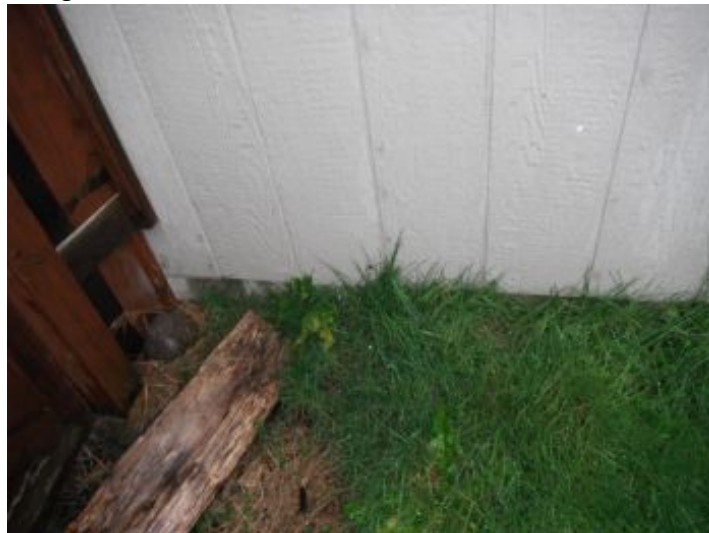
• There was siding in contact - or in close proximity - to soil. This is a conducive condition for wood destroying organisms. We recommend grading soil so there is at least 6" of space (where practical) between the siding and the soil below and checking for any damaged trim and siding materials.

siding in close proximity to the ground

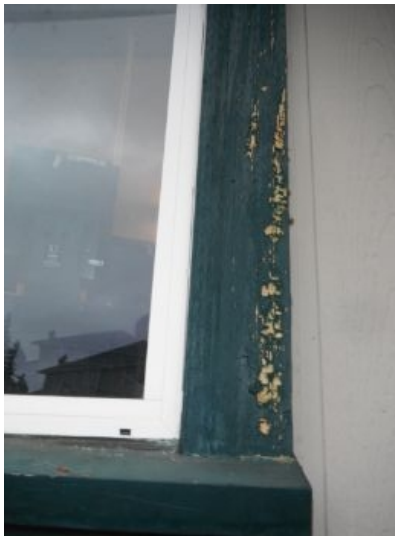
- Some areas of the eaves, fascia, soffits, and door and window trim have worn, cracked, or blistered paint. In order to protect the trim, the areas in question should be scraped, primed and painted. In addition, all caulked areas should be refreshed before painting.

paint failing

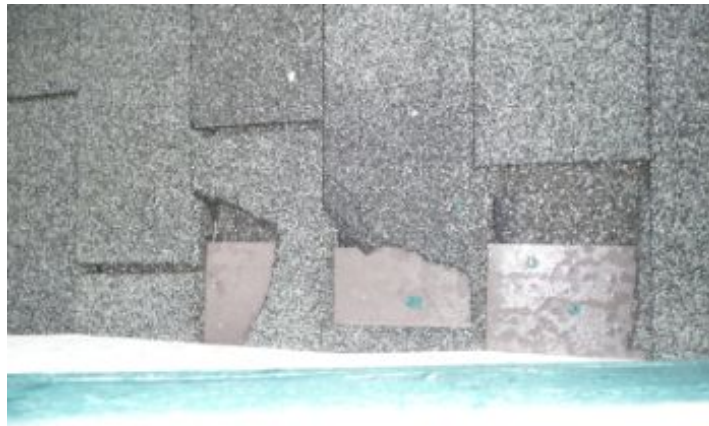
- The roof was not traversed because in the inspector's opinion it could not be traversed safely.
- The roof was inspected from the eaves.
- The roof was inspected from the ground.
- The roof was inspected from windows.
- The roof appeared functional at the time of the inspection.
- There were a few torn shingles observed at a side wall junction. A roofing contractor should review and repair as necessary.

missing shingles at sidewall junction

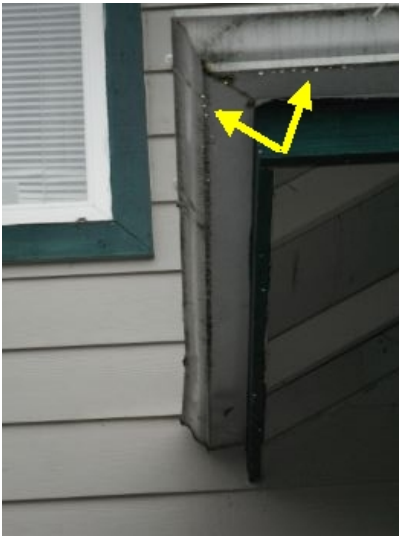
leaking gutter

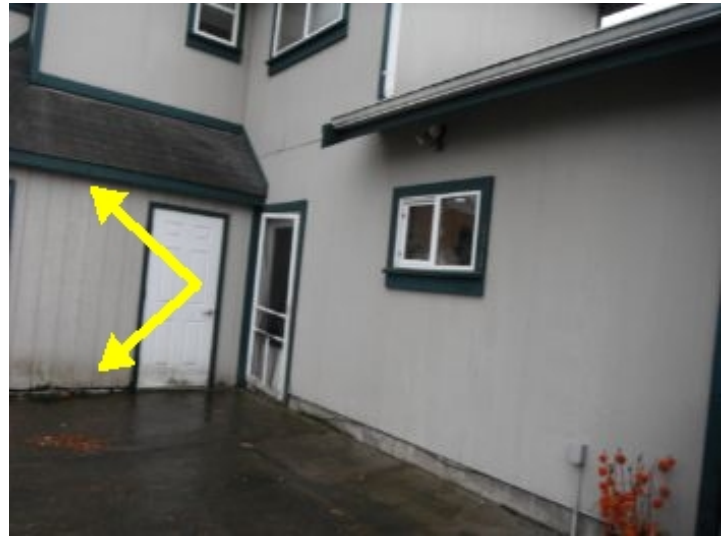
missing gutter causing splashing

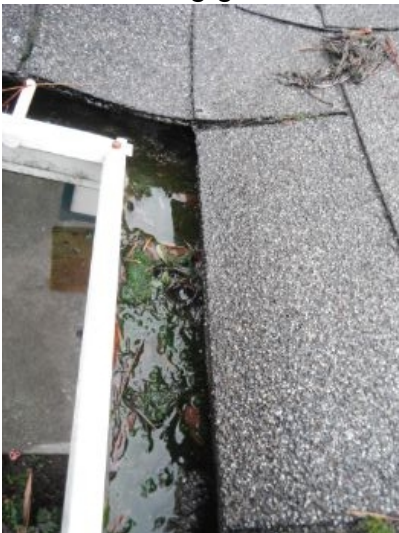
- The gutters are aluminum.
- Significant amounts of debris was observed in the gutters. This can lead to clogs and overflows, resulting in possible fascia and soffit damage and water accumulating around the structure. They should be cleaned out now and checked at least twice a year to prevent future problems.
- There were several areas - gutter/downspout joints and interior corners - that showed evidence of leaking. We recommend having a licensed gutter contractor review for repair and/or replacement.
- There is an added storage area on the rear/east side of the home whose roof does not have a gutter installed. This is causing splashing onto the siding and will greatly accelerate siding deterioration.
- Several gutters are full of water. This would suggest that they are either plugged or sloped in the wrong direction. We recommend they be cleaned and then possibly re-sloped.

gutter full of water and debris

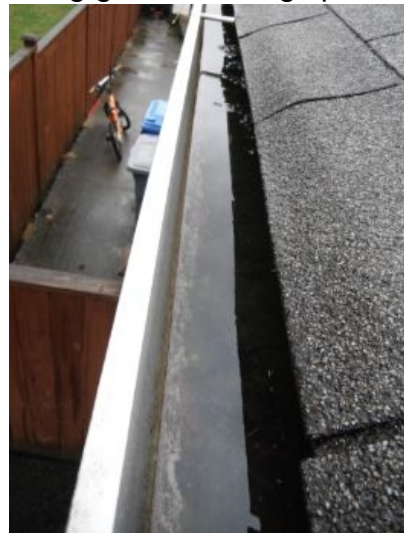
gutter full of water

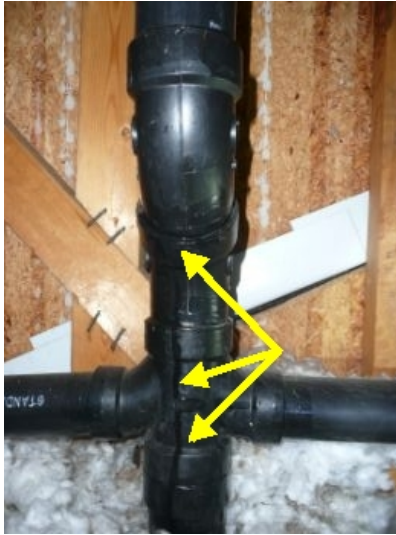
- The plumbing vent pipe is leaking. It should be repaired by a licensed plumber.

leaking plumbing vent line

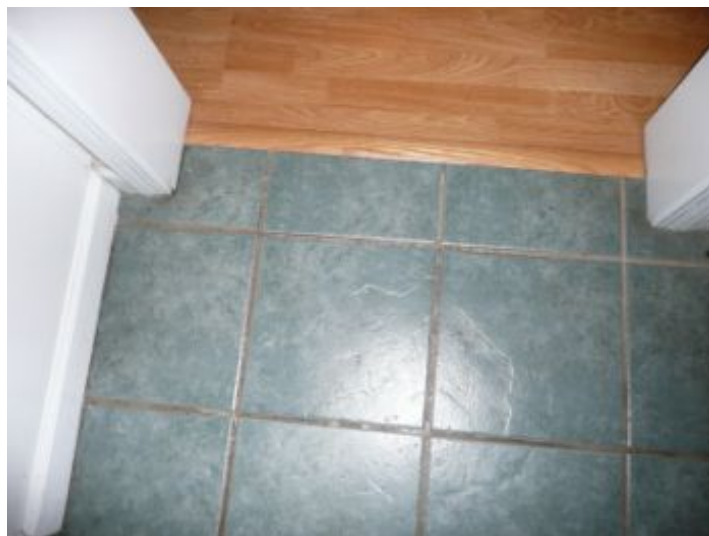
- The flooring in the kitchen appeared functional at the time of the inspection.
- There are areas of flooring where the grout has broken out. It was not possible to determine the reason; we recommend the areas be regouted.

missing grout

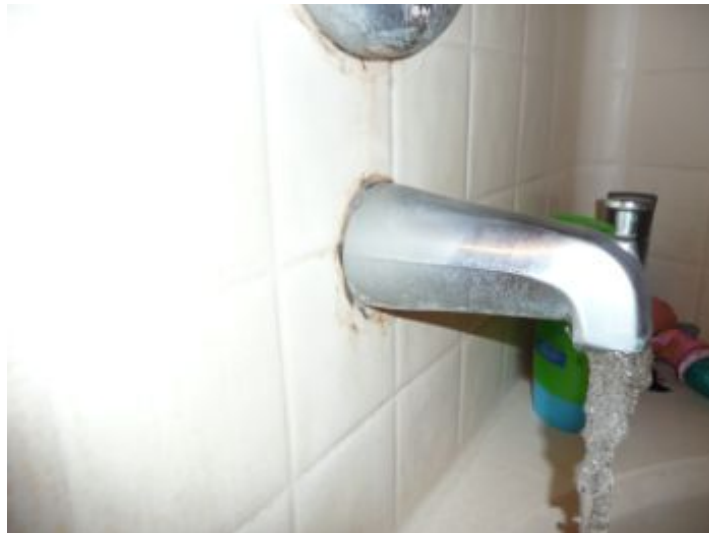
- No deficiencies or problems were observed with this one-piece tub/shower combination.
- Stains were observed on the tub that may not be cleanable.
- The tub/shower faucet appeared functional and operational at the time of the inspection.
- The faucet caulking appears to have deteriorated. The faucet should be resealed to the shower wall.

faucet in need of caulk

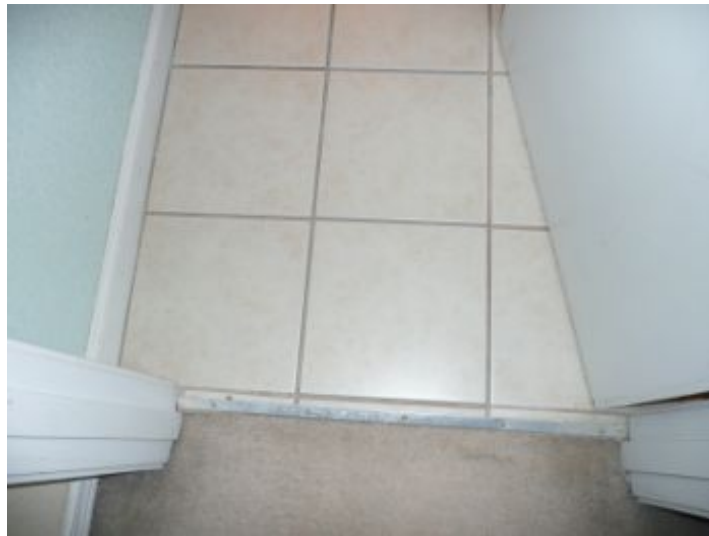
- Damaged grout was observed; we suggest regrouting as necessary.

missing grout

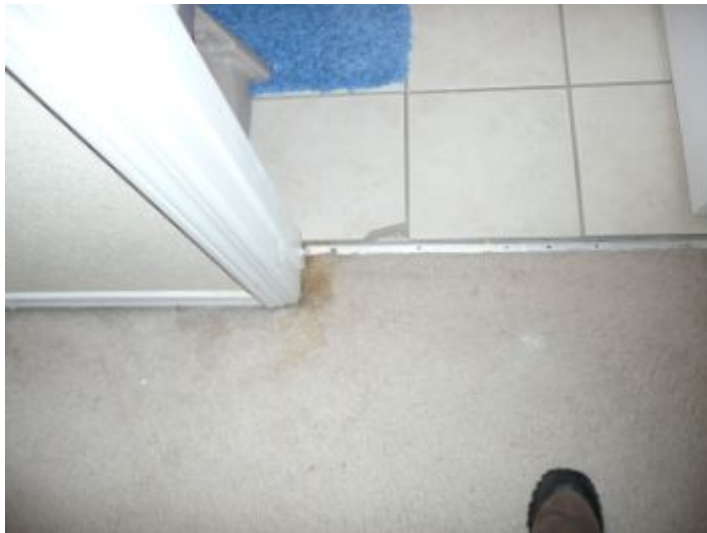
- There is a chip in the floor tile at the entrance to the bathroom.

crack in floor

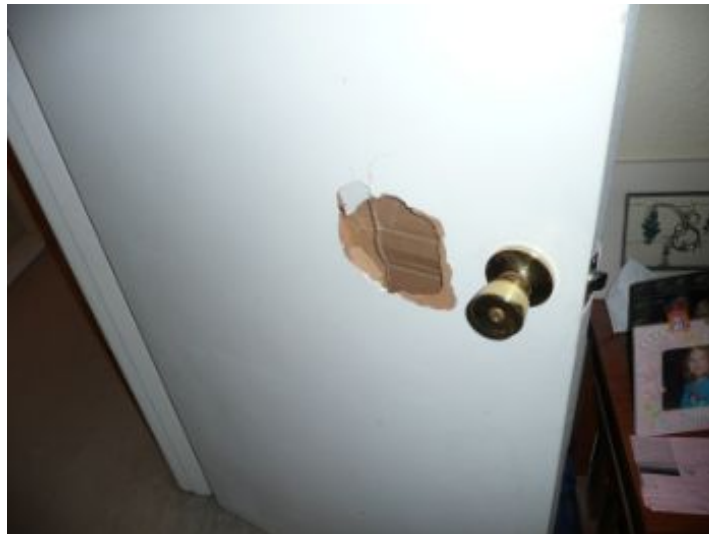
- The bedroom doors appeared functional and operational at the time of the inspection.
- One of the bedroom's door stop is missing and we recommend this be rectified to avoid wall damage.
- The master bedroom door has a large hole in it. We recommend it be replaced.

broken door

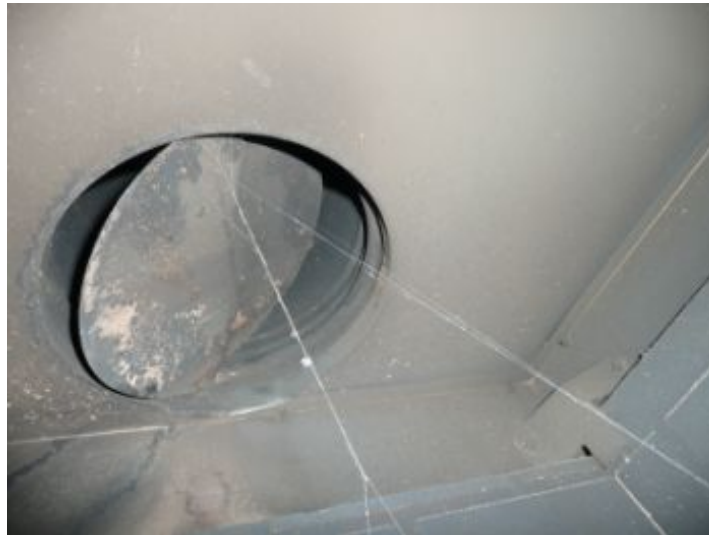
- The National Fire Protection Association (www.nfpa.org) advises that each chimney, regardless of fuel used, receive a Level II inspection each time a residence is sold. Inspection levels are explained at www.csia.org/PressRoom/PressReleases/003Levels/tabid/76/Default.aspx. We recommend that you have this inspection conducted by a chimney sweep certified by the Chimney Safety Institute of America (www.csia.org).
- The fireplace damper lever will not completely close the damper. It remains open and for energy efficiency reasons should be fixed/adjusted so that the damper can close.
- This chimney should be cleaned before it is used.

damper not fully closing

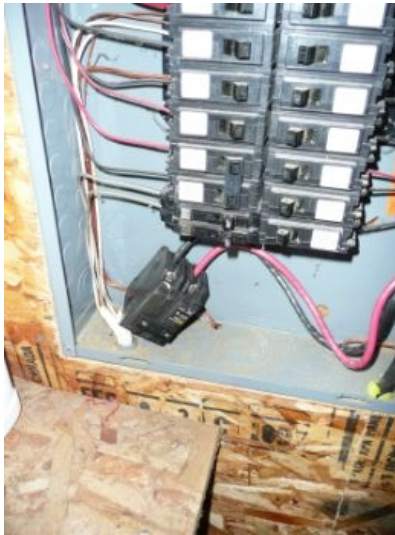
| Building Exterior | | |
|---|---|---|
| Page 28 Item: 4 | Service Panel | <ul style="list-style-type: none"> There is a 50-amp wired breaker hanging loose in the electrical panel. With the cover on, the breaker cannot be seen. It is not attached to the buss bar; it cannot be determined if it is energized or not. This is a safety issue; we recommend having a licensed electrician assess and make repairs as necessary. |

- There is a 50-amp wired breaker hanging loose in the electrical panel. With the cover on, the breaker cannot be seen. It is not attached to the buss bar; it cannot be determined if it is energized or not. This is a safety issue; we recommend having a licensed electrician assess and make repairs as necessary.

floating 50 amp breaker

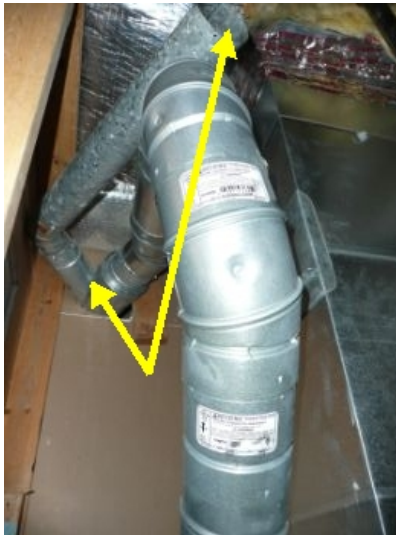
| Building Exterior | | |
|---|---|---|
| Page 29 Item: 5 | Venting | <ul style="list-style-type: none"> This home originally had a gas-fired tank water heater installed. When the changeover to a tankless system was made, the original metal vent pipe was simply abandoned. It joins the furnace metal vent pipe at a 'Y' joint. This is a significant safety issue; if the vent pipe downstream of the joint becomes blocked in any way, the furnace will expel CO gas directly into the home. This must be reviewed and repaired by a licensed HVAC contractor. |

- This home originally had a gas-fired tank water heater installed. When the changeover to a tankless system was made, the original metal vent pipe was simply abandoned. It joins the furnace metal vent pipe at a 'Y' joint. This is a significant safety issue; if the vent pipe downstream of the joint becomes blocked in any way, the furnace will expel CO gas directly into the home. This must be reviewed and repaired by a licensed HVAC contractor.

abandoned water heater vent

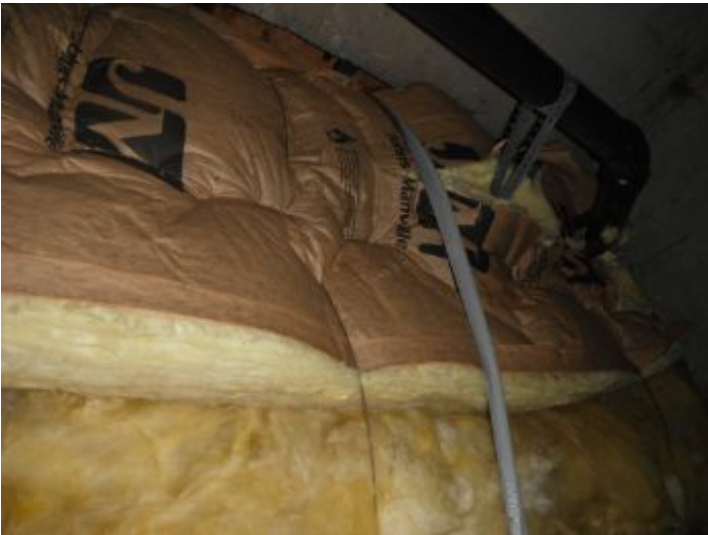
- There was fiberglass batt insulation installed in the crawl space ceiling.
- One section of fiberglass batt insulation was installed upside down. The vapor barrier facing is intended to be on the warm side of the floor plane. As installed, potential moisture problems can occur with the floor structure. We recommend it be removed and reinstalled correctly.
- Some of the fiberglass batts have become dislodged. They should be put back into position and secured.

section of insulation installed upside down

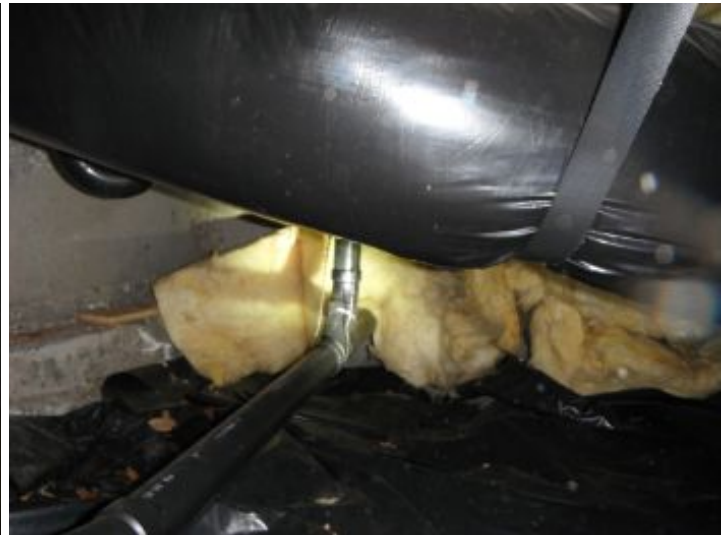
displaced insulation

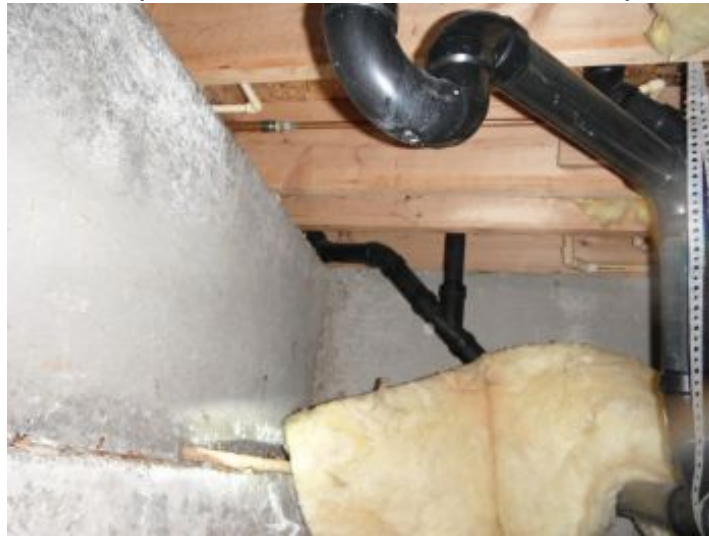
displaced insulation

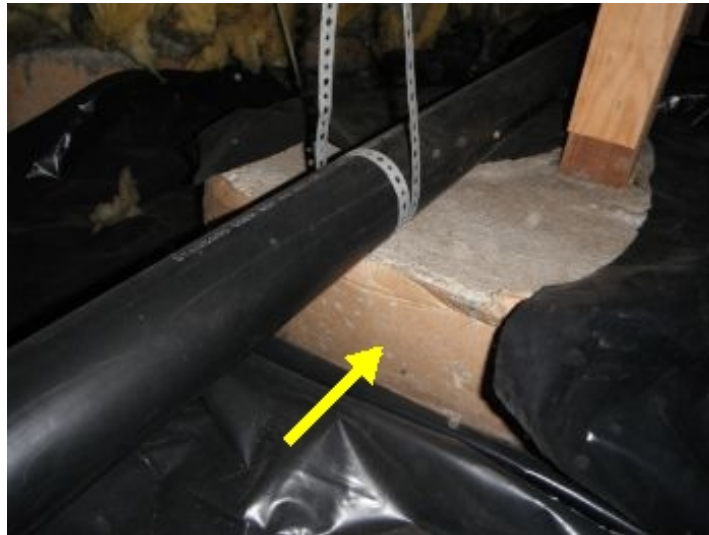
- There is siding in direct contact with the ground at several locations. There should be several inches of space between siding and earth, but creating even an inch of clearance will reduce the likelihood of a wood destroying organism infestation.
- There is at least one concrete pier support with its cardboard form still in place. Cellulose material in contact with soil is a conducive condition for wood destroying organisms. The cellulose material should be removed and discarded.

carboard form still in place
