Watermeade Valley Home Inspection

Property Inspection Report

7654 Main St SE, Olympia, WA 98501

Date of Inspection: 7/9/2012 Time: 11:00 AM

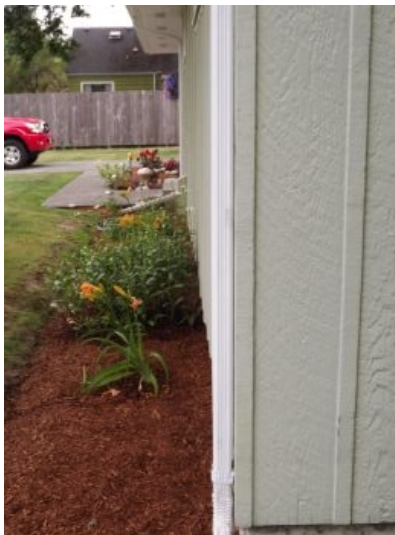
- Bushes and ornamental plantings, even at full growth, should be kept at least 12" away from the home. Plants that are in contact or close proximity to the home limit the flow of air, can lead to moisture problems, and are a conducive condition for wood destroying organisms.
- Plant material was observed in contact or in close proximity with the home. This should be cut back at least 12" from the home.

plants in contact with siding

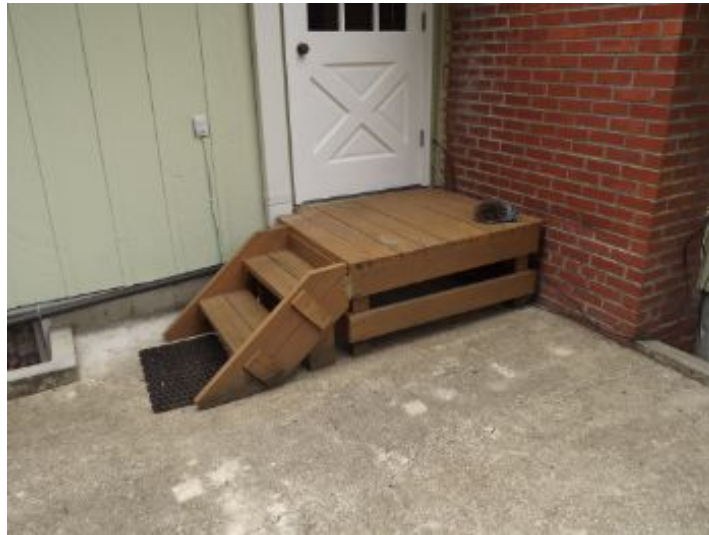
- The porch appeared functional at the time of the inspection.
- No handrail was present. There should be handrails for any set of stairs with 3 or more steps. A handrail should be installed at a height of no less than 34" and no higher than 38" by a qualified contractor.

stairs without handrail

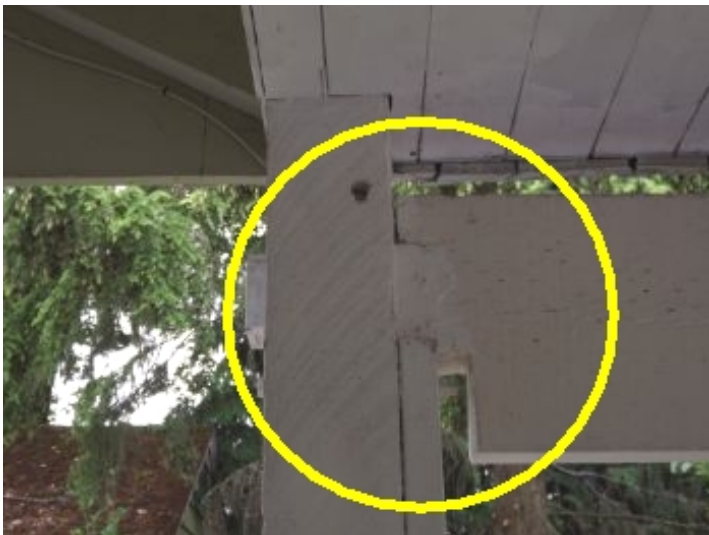
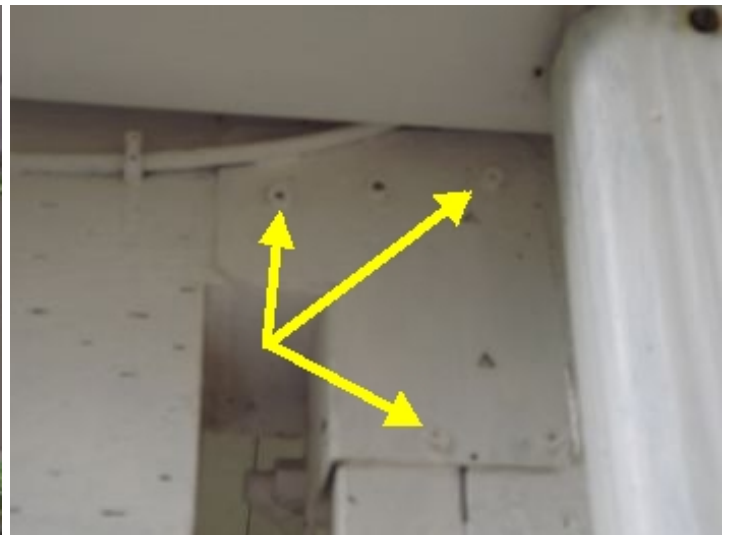
- There was some common cracking noted in the concrete surface.
- The carport and patio cover is supported by joists that run to a beam. One end of the beam appears to be inadequately supported. It rests on a 1X support piece bolted to the post and is hung on joist-type hangers that are nailed on one side and screwed on the other. It is unlikely that the screws have been designed for the shear forces implied; the structure appears unsafe under unusual loads such as snow and/or seismic activity. We recommend having a licensed contractor and/or a licensed engineer review the structure as built for the purpose of formulating a proper solution.

improvised beam attachment

improvised beam attachment with screws

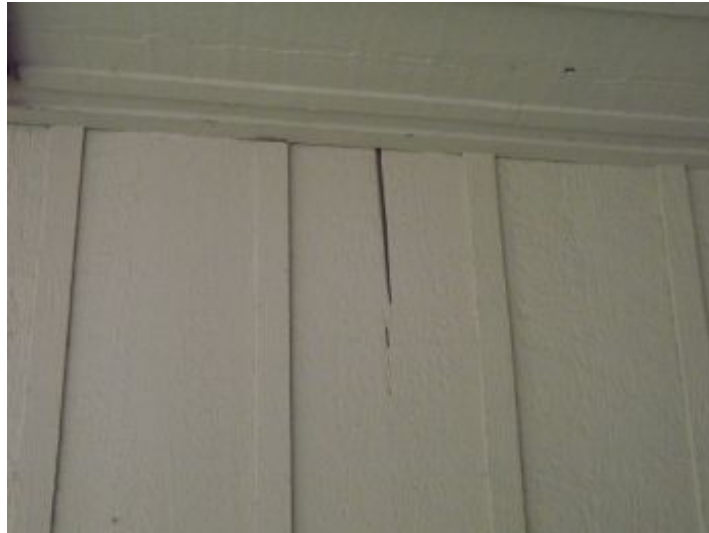
- There were some cracks noted in the wood siding. This can lead to water intrusion into the structure; they should be caulked and repainted to remain sealed.

siding crack

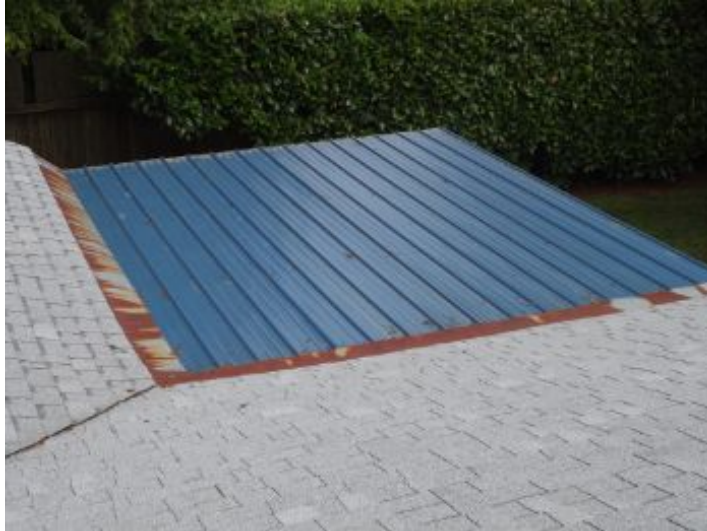
- No deficiencies or problems were observed with this roof.
- The roof was traversed.
- The metal transition flashing between the asphalt roof and the low slope metal roof over the back half of the carport is rusting and will likely fail before the asphalt roof does. Given that it is not over living space and therefore not likely to create expensive repairs, we would recommend monitoring the issue.

corroding transition sheetmetal

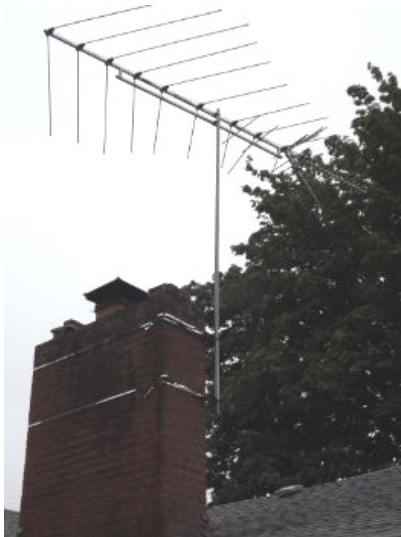
antenna attached to chimney

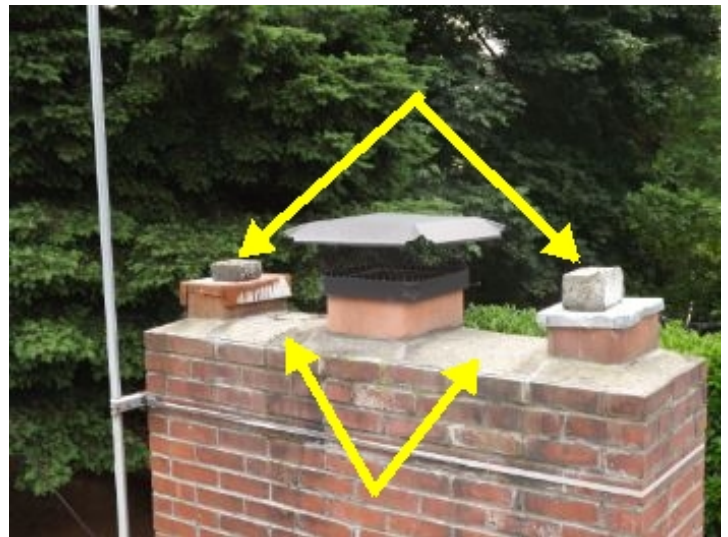
- No chimney cap was visible; a simple mortar wash was used instead. A chimney cap can help prevent spalling, mortar deterioration, and water intrusion. We recommend having a qualified mason install a proper chimney cap.
- A television antenna is attached to the chimney structure. Chimneys are not designed for lateral forces and can be damaged by the antenna. It needs to be taken off of the chimney, and if having one is still desired, a more appropriate roof deck attachment should be installed.
- Two of the three chimney flues are covered with sheet metal weighted down by unattached masonry used as dead weight. This can create a hazard in a high wind. We recommend having a qualified mason use a more secure method for closing off the flues.

no chimney cap and unattached dead weights

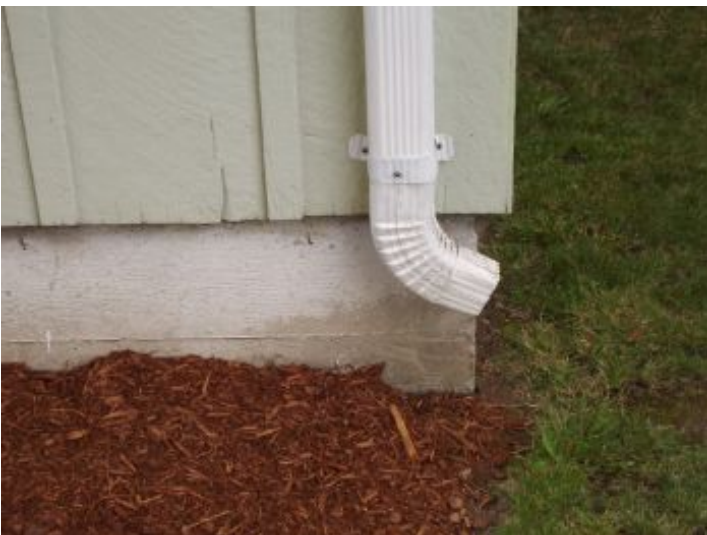
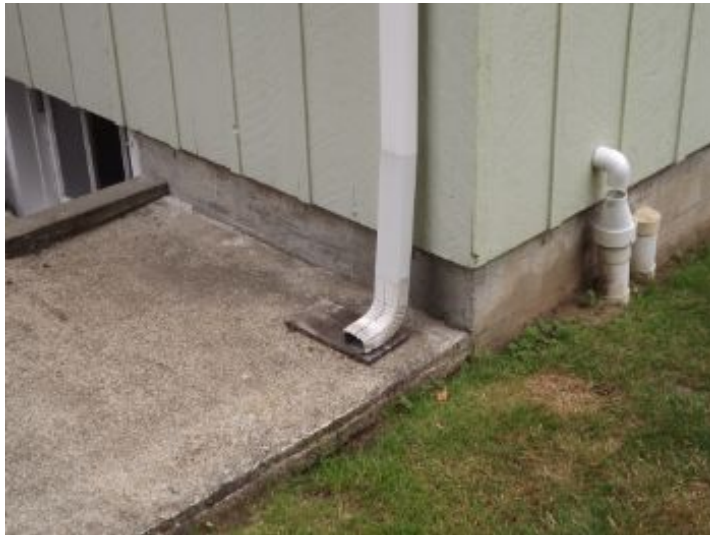
- Several downspouts have no extensions/splash blocks, or have extensions/splash blocks that are ineffective. This can result in water accumulating around the foundation or in the basement. Accumulated water is a conducive condition for wood destroying organisms and may also cause the foundation to settle and possibly fail over time. Repairs should be made as necessary, such as installing extensions or repositioning splash blocks so that rainwater is carried several feet away from the structure.

downspout with no splashblock

downspout without adequate splashblock

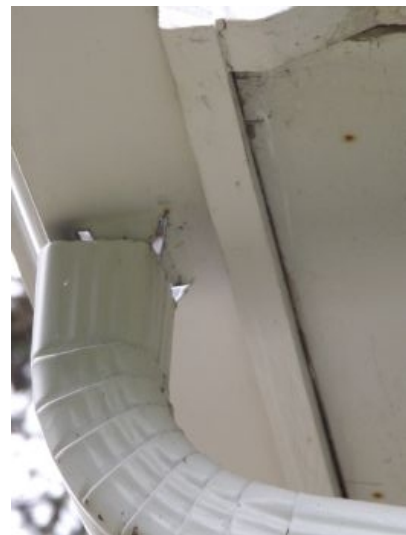
inadequately attached downspout

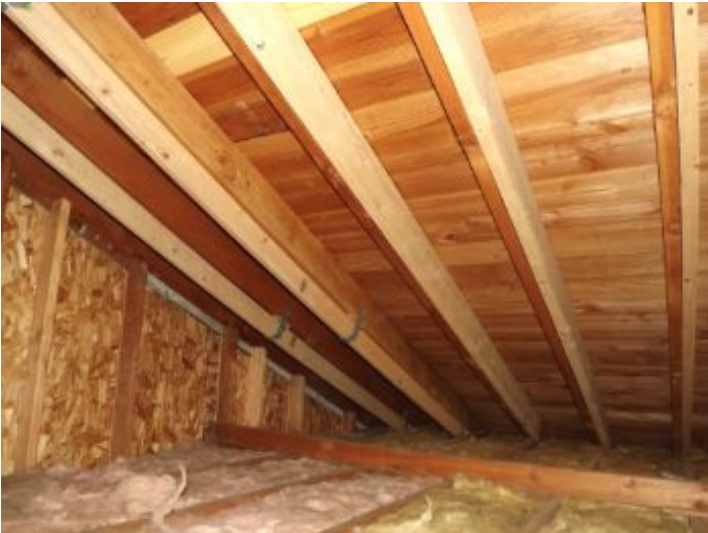
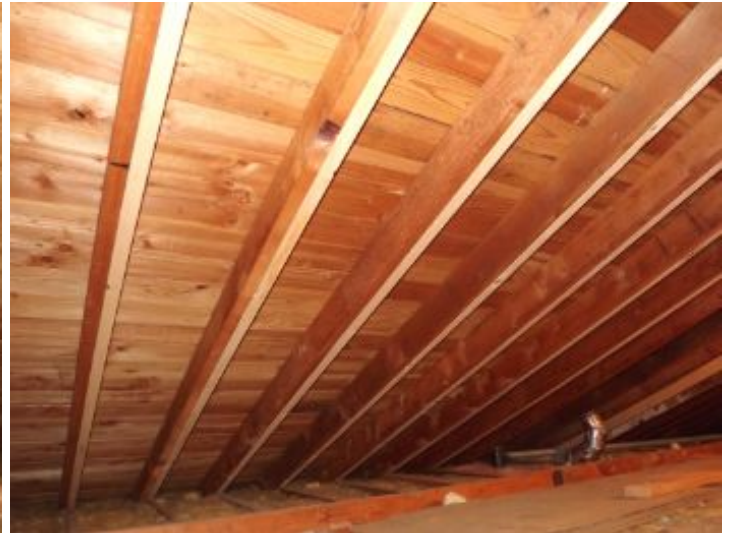
- The roof framing appeared functional at the time of the inspection.
- One whole section of attic had newer structural members 'sistered' to the original rafters. The reason for this reinforcement could not be determined.
- There was evidence of past water leaks, but no evidence of current leaks. We recommend monitoring the attic during our wet season.

'sistered' roof rafters

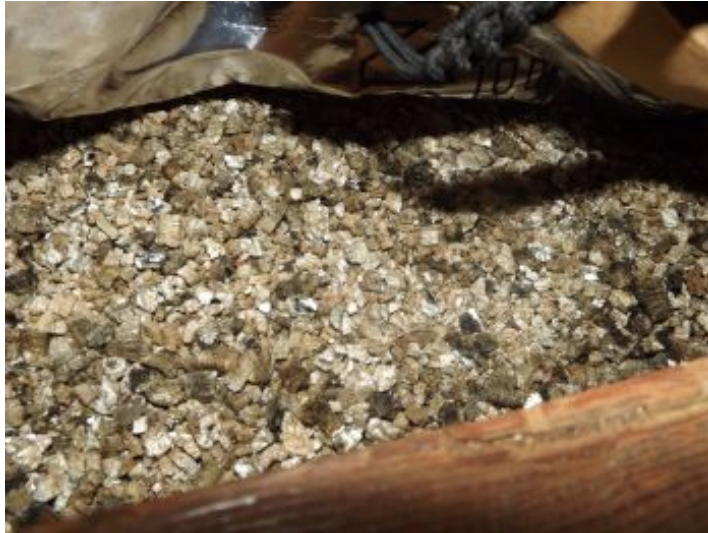
- The attic hatch was not insulated. We recommend it be weather stripped and insulated to the same R-value as the rest of the attic.
- Vermiculite insulation was observed in the attic; it should be assumed to contain asbestos. This material should not be disturbed in any way. If you choose to have it removed, you should have a licensed asbestos abatement contractor do the work. For more information, go to <http://www.epa.gov/asbestos/pubs/verm.html>.

vermiculite insulation

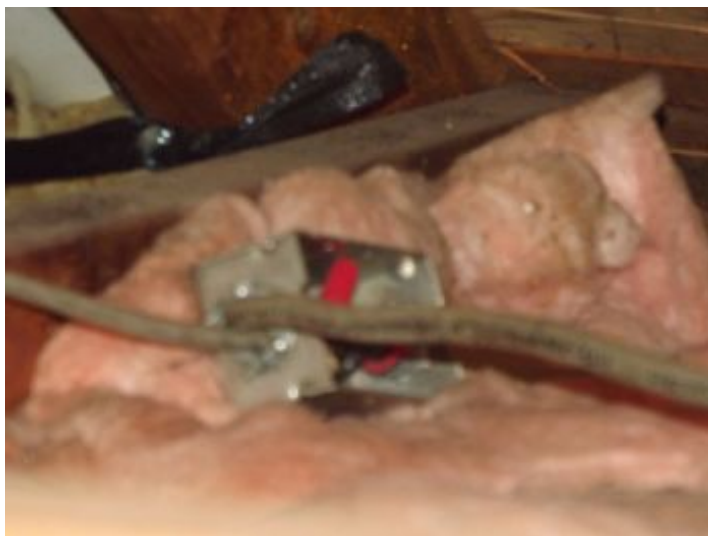
- The attic's electrical system appeared functional and operational at the time of the inspection.
- A cover plate is missing on a box that is unsecured to a framing member. This is a safety hazard and it should be repaired.

unsecured and uncovered electrical box

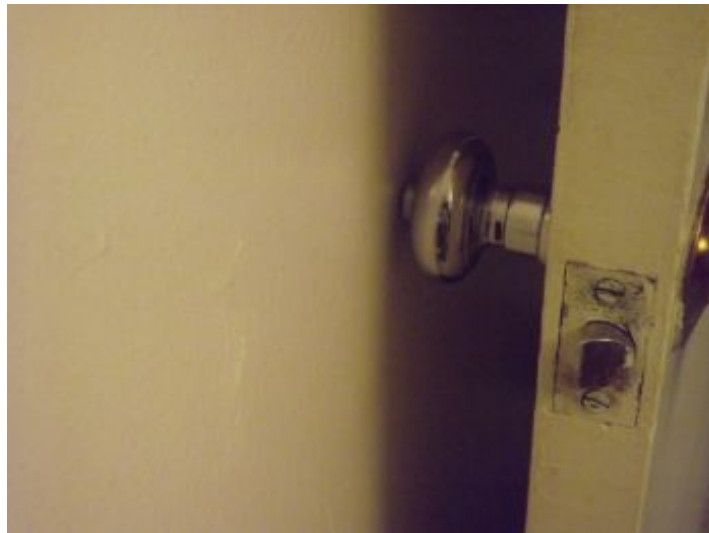
- No deficiencies or problems were observed with the bathroom doors.
- The door stop is missing and/or ineffective and we recommend this be rectified to avoid wall damage.

no doorstop will lead to wall damage

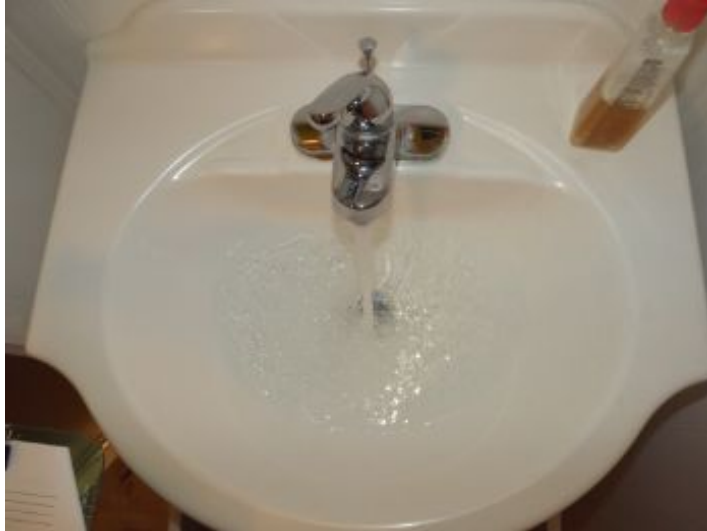
- No deficiencies or problems were observed with the sink.
- The client should be aware that this sink does not have an integral overflow drain. If accidentally left to run, this sink will overflow.
- No deficiencies or problems were observed with the supply lines and faucets.
- No deficiencies or problems were observed with the drains.

no overflow outlet in sink

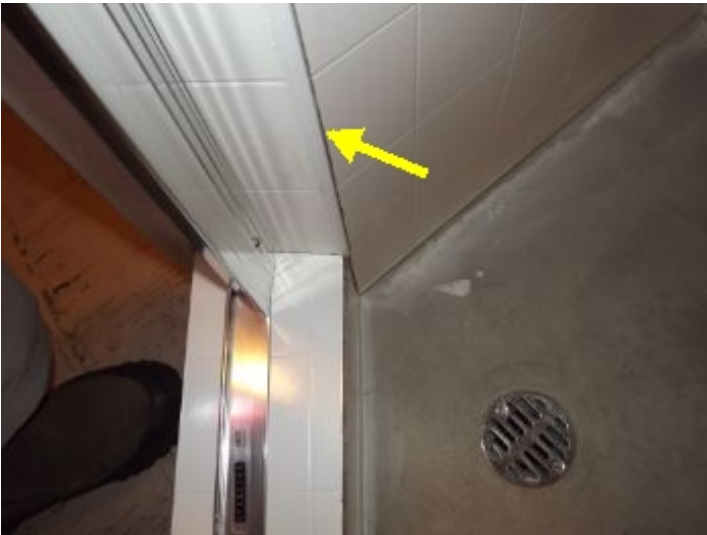
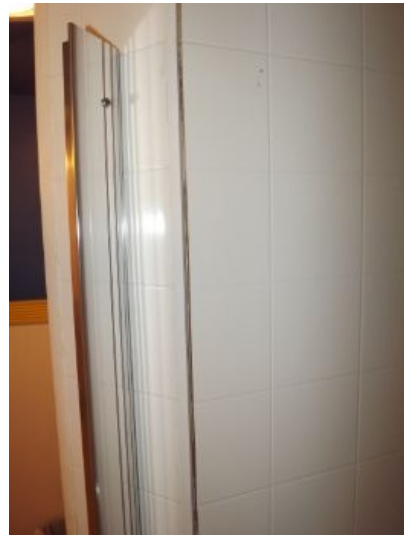
- No deficiencies or problems were observed with the shower base.
- the shower base is bare concrete.
- No deficiencies or problems were observed with the shower faucet.
- No deficiencies or problems were observed with the shower doors.
- The shower walls are a panel product made to resemble tile and likely made of a wood fiber product. The installation is improvised and edges/seams are exposed. The panels will likely have a short lifespan as currently installed.

exposed edge of shower wall material

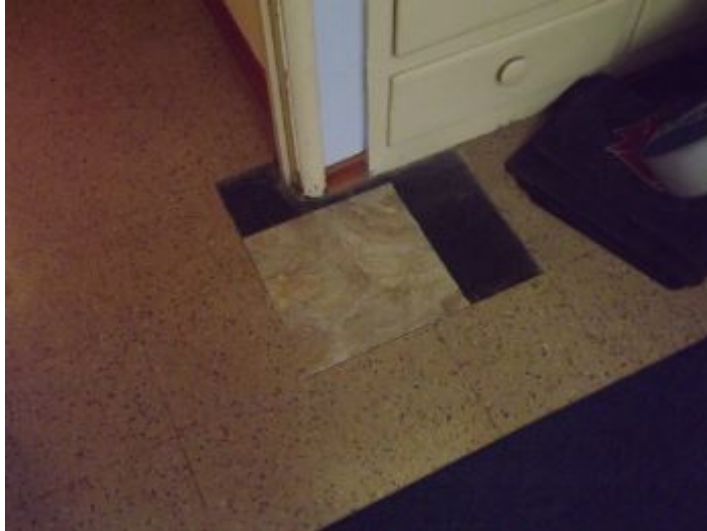
- The flooring in the bedrooms appeared functional at the time of the inspection.
- The flooring in some of the rooms is vintage 9x9 vinyl tile; these tiles are known to often have an adhesive containing asbestos. You should refrain from removal and/or damaging these tiles until you have had them professionally tested.

damaged 9X9 vinyl tile

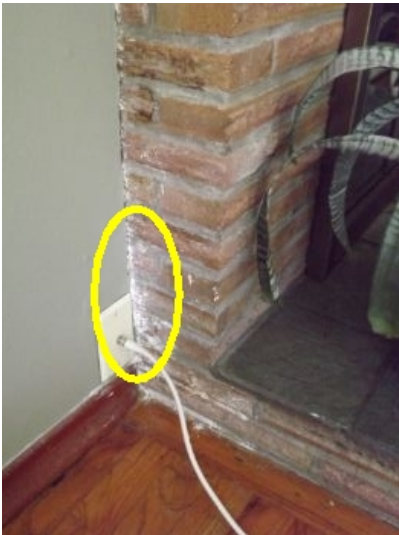
- There is efflorescence noted at the back lower corners of the brick fireplace enclosure, suggesting water intrusion in the chimney, possibly from the lack of an adequate chimney cap. We recommend it be evaluated at the same time as the level II inspection.

efflorescence at side of fireplace

- Unless and until this fireplace and chimney receives a clean report from a level II inspection conducted by a certified chimney sweep, we recommend it not be used.

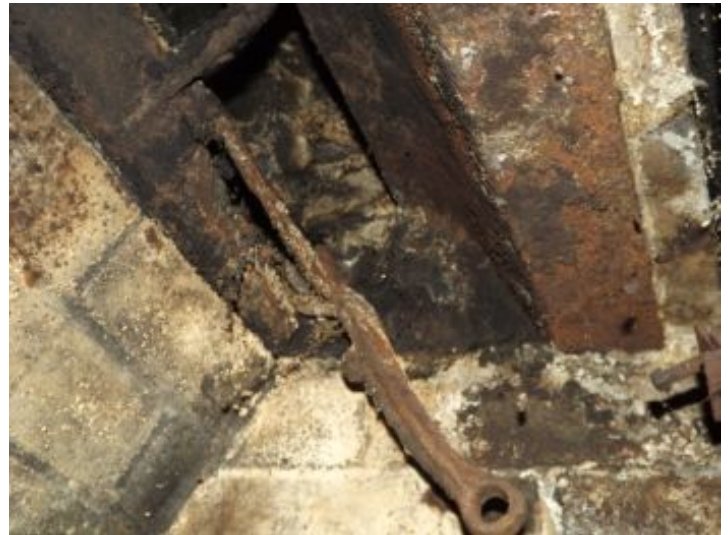
- There is significant rust noted on the damper mechanism. This should be further evaluated during the level II inspection.
- There is vertical cracking noted on the backwall of the firebrick enclosure. This should be further evaluated during the level II inspection.

corroding damper

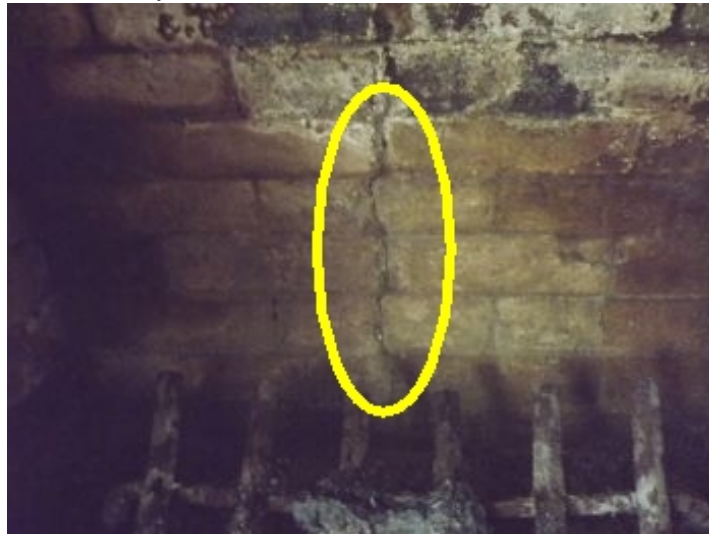
vertical crack in firebrick

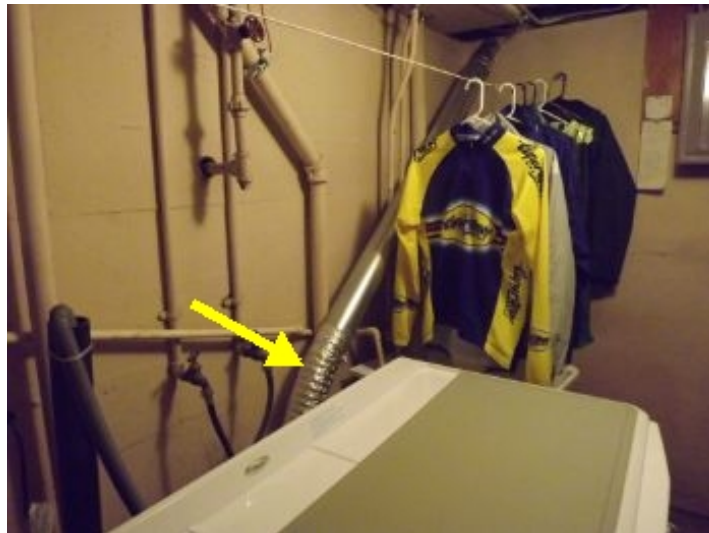
- The dryer vent appeared functional and operational at the time of the inspection.
- The dryer vent pipe is both rigid metal duct and a foil accordion-type flexible duct. The U.S. Consumer Product Safety Commission considers these ducts to be a fire hazard. We recommend that this duct be replaced with a rigid or corrugated semi-rigid metal duct.

corrugated foil exhaust pipe

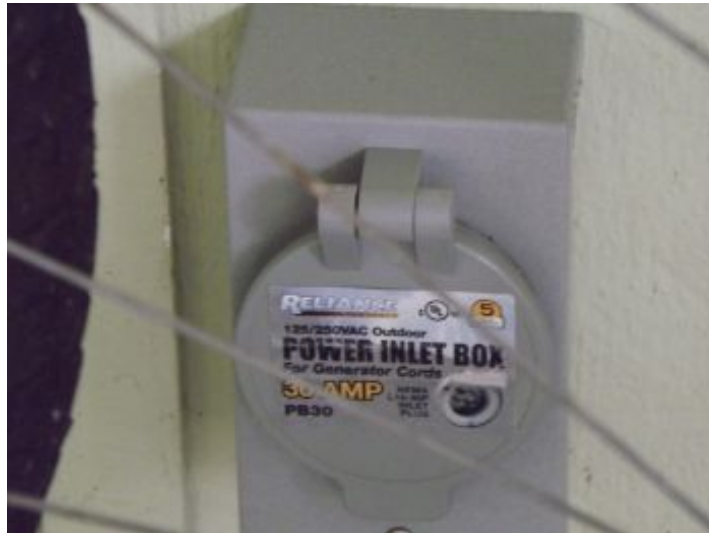
- No deficiencies or problems were observed with the main electrical panel.
- The panel is wired for a generator, with an inlet plug on the exterior east side of the home. No generator is present.

generator inlet plug

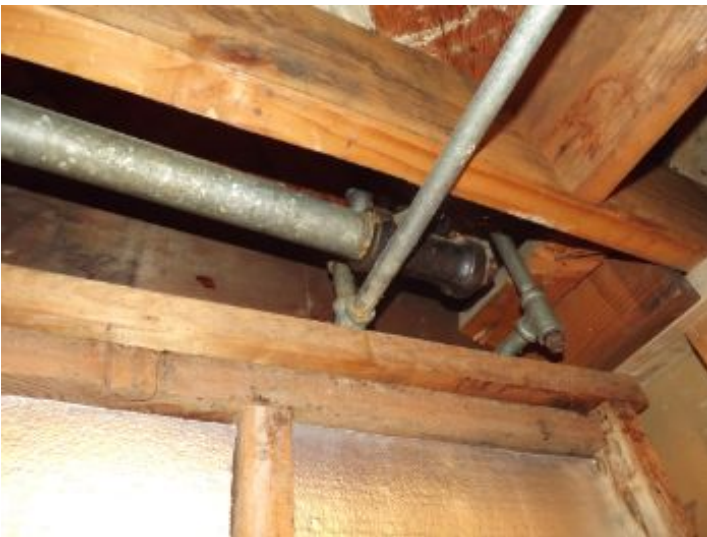
- All of the observed water supply pipes in this structure are made of galvanized steel. Based on the age of this structure, these pipes may be nearing or may have exceeded their estimated useful life of 40 to 60 years. Internal corrosion and rust can reduce the inside diameter of these pipes over time, resulting in reduced flow and leaks.

galvanized steel pipe

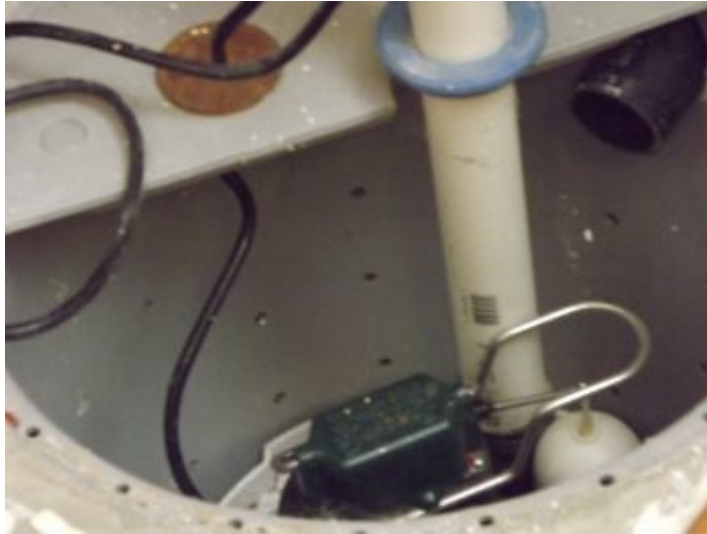
- A sump pump is installed on the premises. This may indicate that water accumulates inside or below the structure. We recommend asking the property owners how often the sump pump operates and for how long at different times of the year. Also, the clients should be aware that the service life of most sump pumps is between five and seven years, and that the pump may need replacing soon depending on its age and how much it operates.
- The sump system appeared functional and operational at the time of the inspection.
- The pump discharges into an unknown location. Further review is recommended to confirm that proper discharge location practices have been followed.

interior of dry sump pump
